COLD REGIONS RESEARCH AND ENGINEERING LAB HANOVER NH F/6 14/5  
INFRARED THERMOGRAPHY OF BUILDINGS: 1977 COAST GUARD SURVEY. (U)  
JUN 79 S J MARSHALL MIPR-7LB731-CO-206  
CRREL-SR-79-20 NL

4. TITLE (and Subtitle)  INFRARED THERMOGRAPHY OF BUILDINGS: 1977 COAST GUARD SURVEY		5. TYPE OF REPORT & PERIOD COVERED
		6. PERFORMING ORG. REPORT NUMBER

7. AUTHOR(s)  Stephen J. Marshall		8. CONTRACT OR GRANT NUMBER(s)
9. PERFORMING ORGANIZATION NAME AND ADDRESS U.S. Army Cold Regions Research and Engineering Laboratory Hanover, New Hampshire 03755		10. PROGRAM ELEMENT, PROJECT, TASK AREA & WORK UNIT NUMBERS U.S. Coast Guard Project MIPR 7LB731CO206

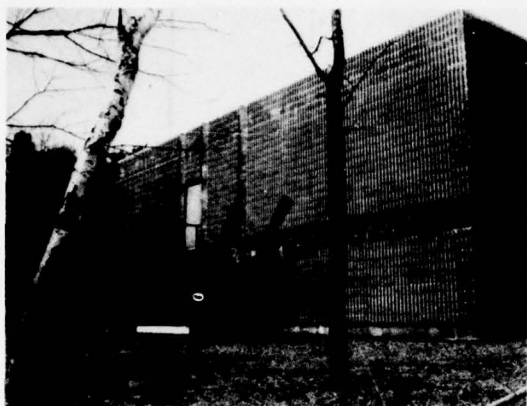
Figure 9. South face of new section at Marshfield station.

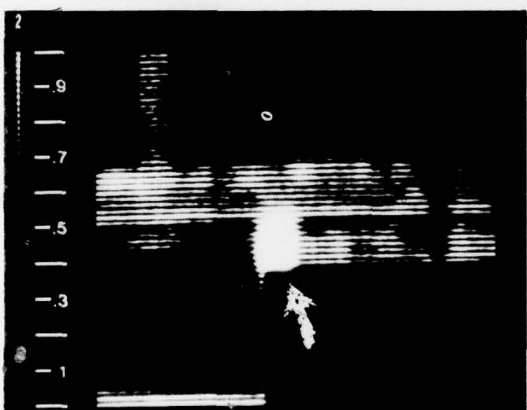
Figure 11 is a closeup thermogram of some of the conventional concrete blocks separating the split-ribbed sections horizontally along the first floor level of the east face. The outlines of some of the individual blocks can be seen as well as a mottled pattern that suggests moisture. This mottled pattern is hard to reproduce on the photographs but is quite clear on the CRT screen. The square white object in the center of the thermogram is the butt end of a floor beam on the z-axis; that is, it lies perpendicularly to the plane of the thermogram and disappears into the picture. Another warm beam end appears less clearly in the middle of Figure 12.

Figure 11. Closeup of floor beam on the east face.

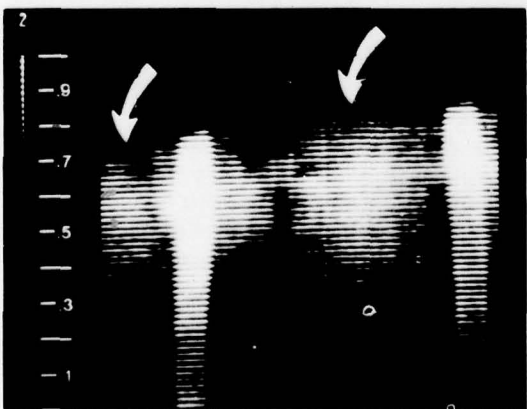
Figure 13. Nonuniform thermal patterns on the east face.

anomalies that suggest spacings equal to the distance between internal 2x4 studding (small arrows, Fig. 12). Figures 13 and 14 are two more examples of the mottled pattern on the east and west faces of the new building. Figure 13 shows two large, circular, warm areas. In Figure 14 the vertical split-ribbed patterns can be made out on the thermogram as well as the outline of the normal blocks in the horizontal section above.

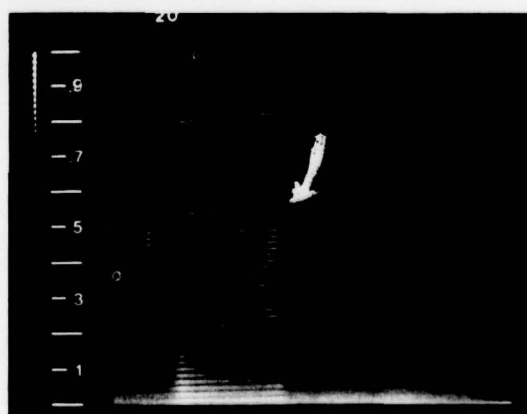
Figure 20. Glass panel under stairwell in connecting section.

Figure 20 shows a glass panel to the left of the chimney and connecting with the new section (white arrow). It was very hot (scale 20) yet serves no useful purpose because it is under the stairwell and unable to provide stairwell lighting. It should be replaced with an insulated panel.

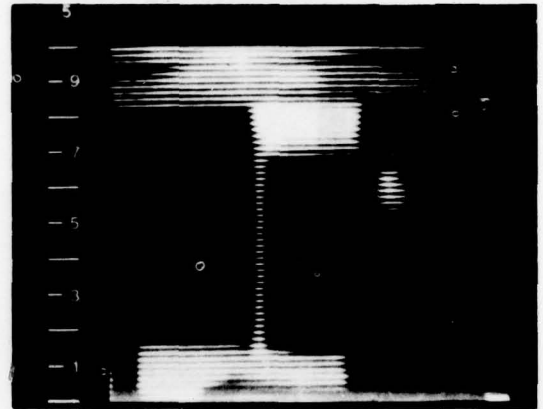
the south face, which reveals an excessive amount of heat loss through the glass transom and around the door. The door itself appears insulated. The concrete block walls appear uniformly insulated and in Figure 24 the actual outlines around each block can be recognized. The foundation is excessively warm, as are the concrete blocks immediately above the transom level and the horizontal precast beams above them.

Figure 23. Closeup of warm foundation, glass transom and door exfiltration.

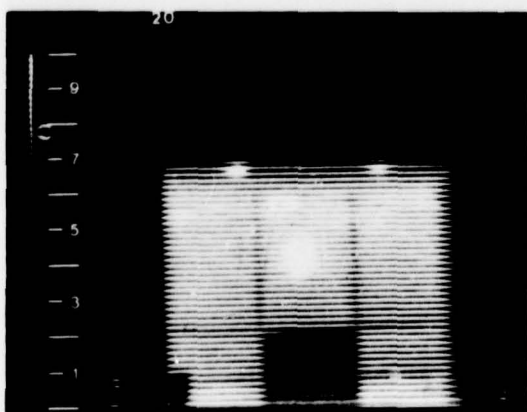
Figure 25 is a photograph of the main entrance on the east face of the building. It contains an excessively large glass area. There is no vestibule and the upper and lower open stairwells are just inside the door. Thermograms in Figures 26 and 27 were taken at a scale of 20, indicating that the glass is a very bad insulator compared with materials in other main entrances. The door itself appears to be uniformly dark and no leakage appears around it even though this door is heavily used.

Figure 26. Glass surrounding main entrance door.

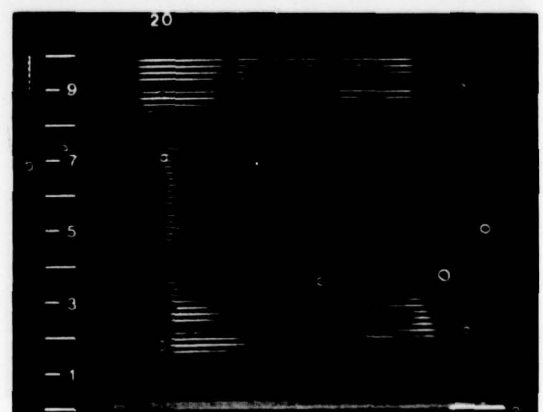
Figure 27. Main entrance door.

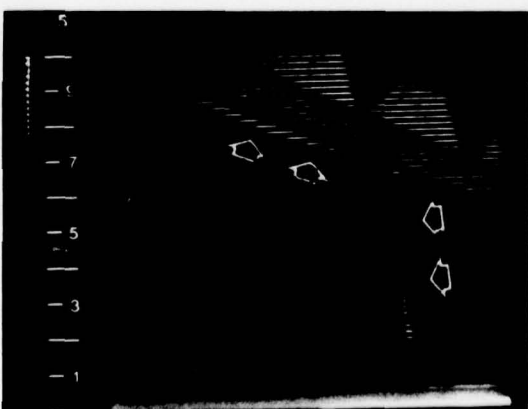
Figure 32. Exfiltration at window/wall interface.

Figure 32 shows upper and right-hand leakage between the window frame and concrete block wall interface (arrows). Figure 33 shows horizontal leakage between the upper and lower panels and between the panels and the concrete block wall (arrows). These wooden panels should be compared with the much superior insulated porcelain panels at the Portland Base (Fig. 93-97).

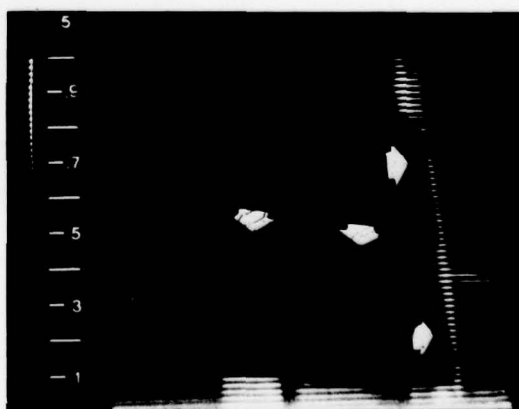
Figure 33. Exfiltration between wooden panels and at panel/wall interface.

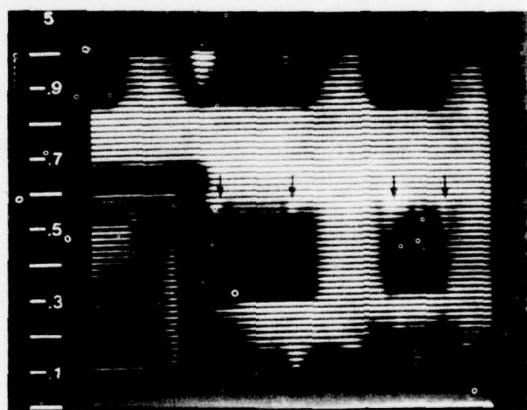
Figure 44. Main entrance with vestibule and boiler room on south face.

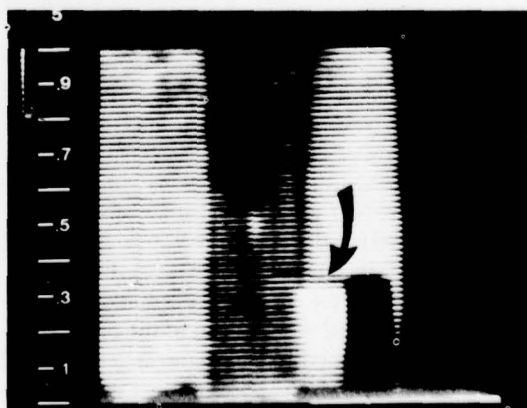
Figure 46. Hot transformer in southeast corner of station.

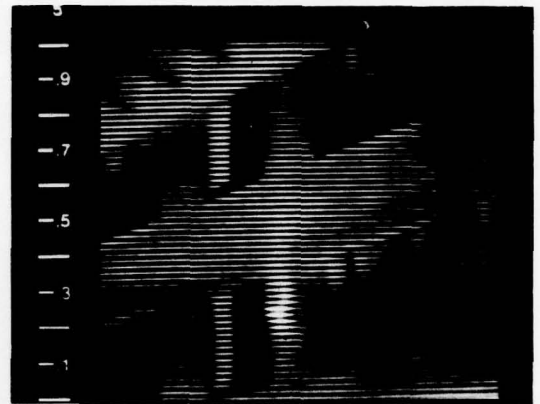
Figure 49. Windows on southeast face.

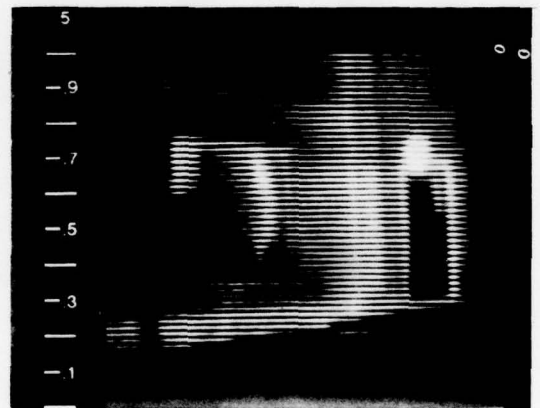
Figure 51. Stairwell door and vertical construction joint.

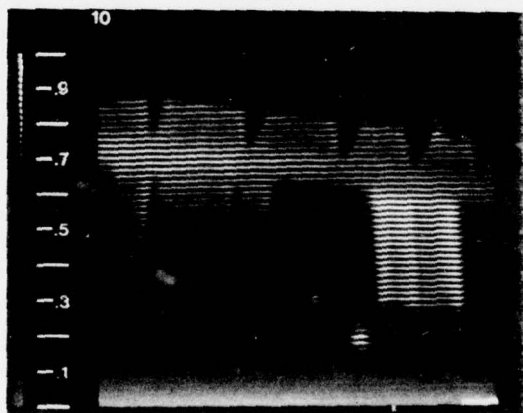
Figure 56. Excessive leakage from window in unoccupied boatswain's locker.

Figure 56 is of a window on the third-deck floor over the main entrance that exhibits excessive heat loss at scale 10. Since the room is an unoccupied boatswain's locker, the window could be replaced with an insulated porcelain panel to conserve energy.

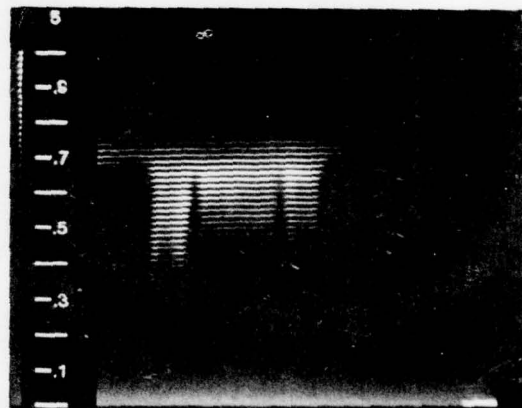
Figure 57. Excessive exfiltration from window/wall interface.

Figure 57 is of the third deck window on the upper right in Figure 54. The patterns on the glass suggest infiltration loss as well as the fact that the top horizontal interface is much warmer than most of the other windows on this face.

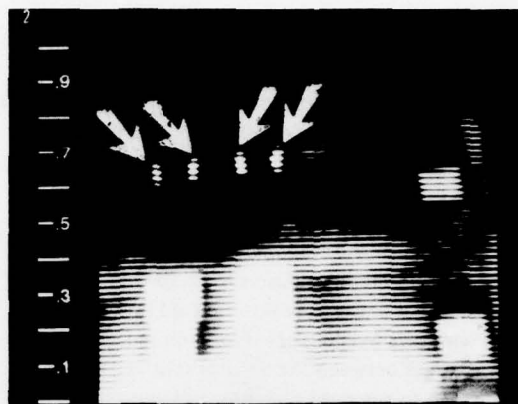
Figure 68. Leaks on both sides of the air conditioner units.

Figure 67 is a photograph of the north face of building 1 taken from the passageway between buildings 2 and 4. Note the two air conditioner units in the windows on the top deck. Figure 68 is a thermogram of these two windows. It shows how the windows themselves and the air conditioner units are dark or cool but the area to the left and right of each air conditioner leaks badly. The brick wall exhibits a cool pattern along the top deck but a warm pattern along the deck below it.

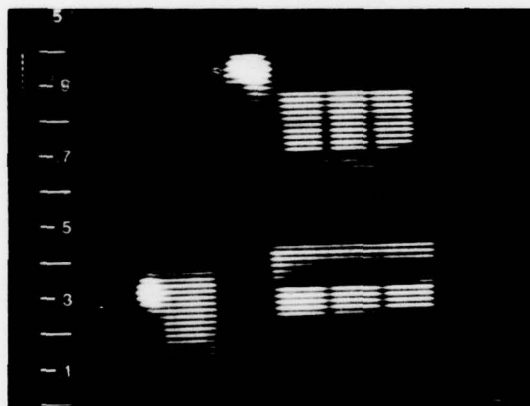
Figure 76. Stairwell door badly sprung, garage door and second deck window.

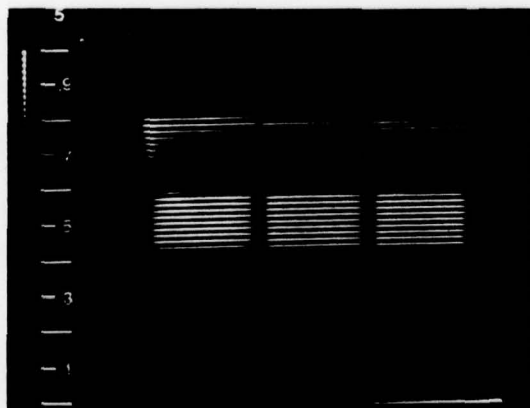
Figure 78. Garage door in northeast corner of building.

Figure 78 is a closeup of the wooden garage door showing the excessive top horizontal leakage and the warm window glass. However, this garage door was not as bad as those at some of the other stations. Figure 79 is the window over the garage door taken at scale 10. All the windows on the north face were closed and had drawn drapes but still exhibited some leakage. This station often has the problem of the entire north face being very cold and the entire south face very warm.

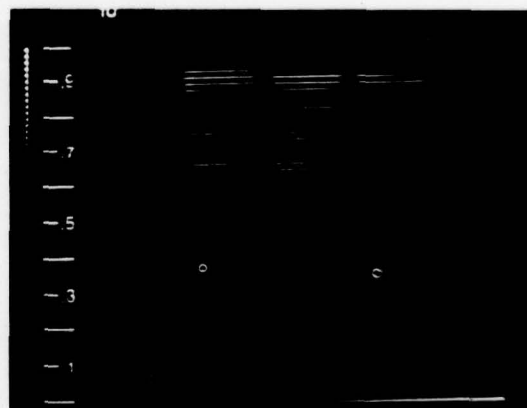
Figure 79. Windows on the north face with drawn drapes.

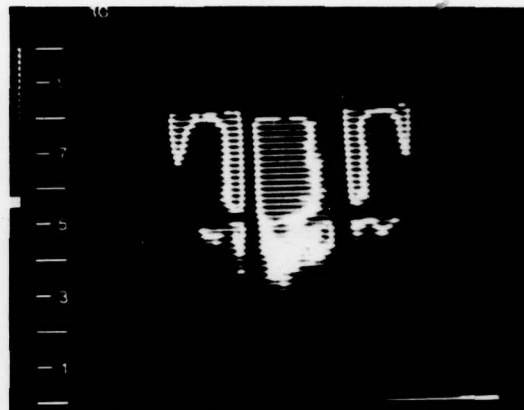
Figure 81. Isothermal infiltration patterns on glass entrance.

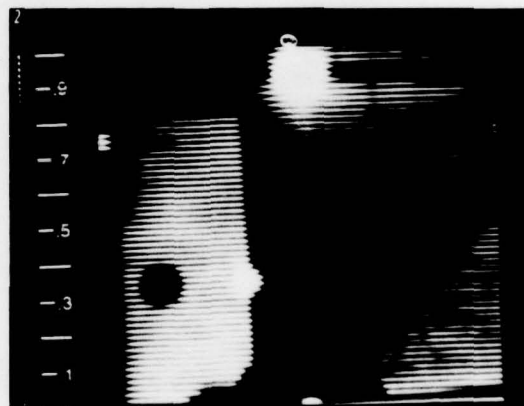
Figure 83. Mottled moisture pattern on west face of stairwell.

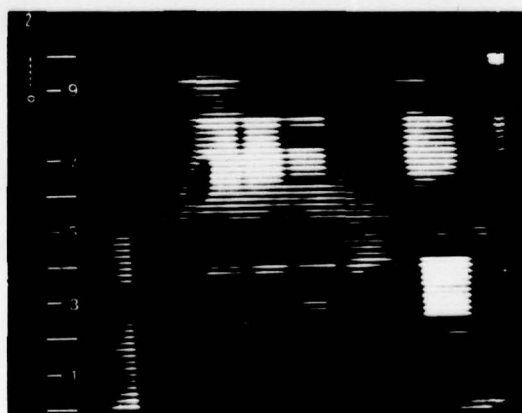
Figure 84. Open second deck windows on south face.

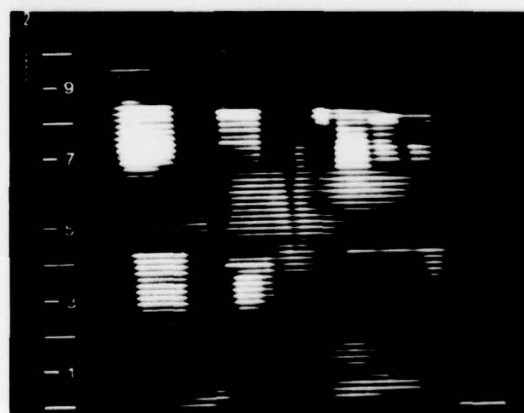
Figure 85. Radiator leakage under windows on south face.

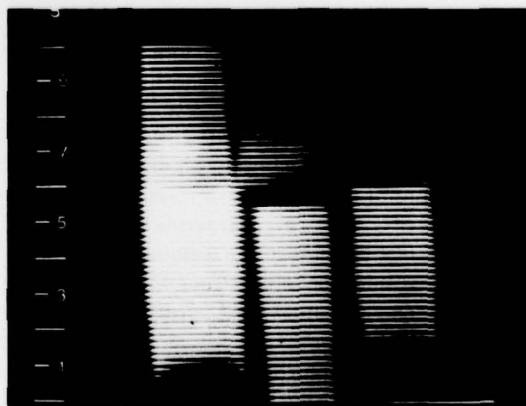
Figure 98. Door in northwest corner with leakage through the surrounding glass.

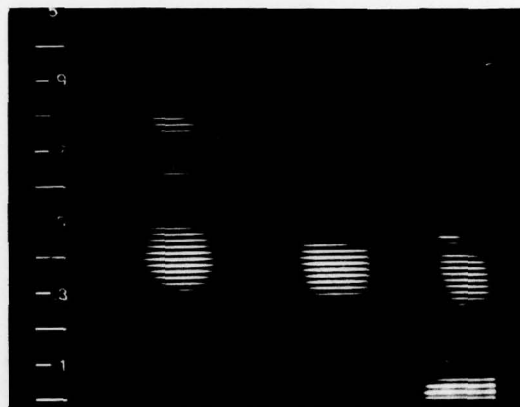
Figure 101. Radiator leakage under windows on east face.

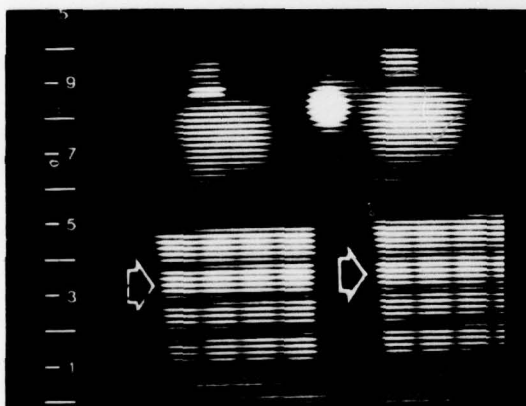
Figures 102 and 104 are thermograms of wooden garage overhead doors at Boothbay Harbor. It can be seen that the individual wooden panels lose as much heat as the glass window panes in the second row from the top of the doors. (The round object in these two thermograms is a spotlight.) Several of the other stations, such as the motor pools at New Castle, South Portland, and Southwest Harbor, exhibited the same kind of leakage through the wooden panels of the overhead garage doors. An overhead garage door found to

Figure 102. Wooden overhead garage doors with windows in them.

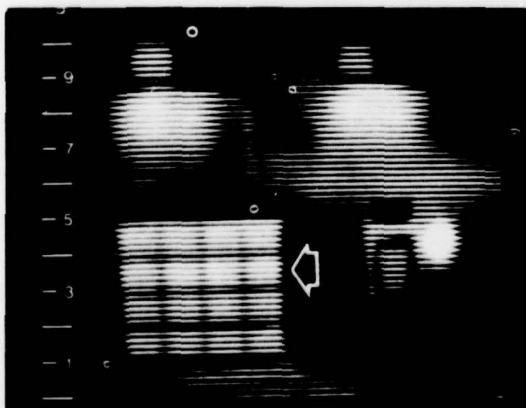
Figure 104. Leakage around door that is frequently used.

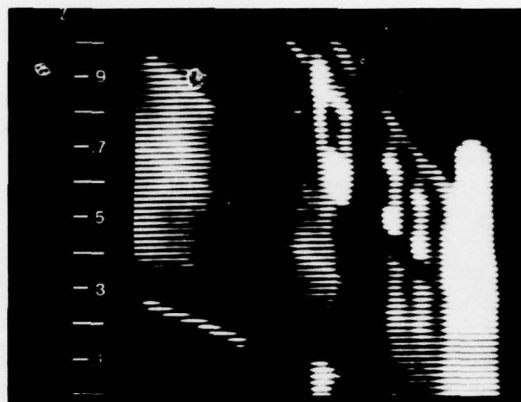
Figure 114. Radiator leakage under windows shows clearly on north face.

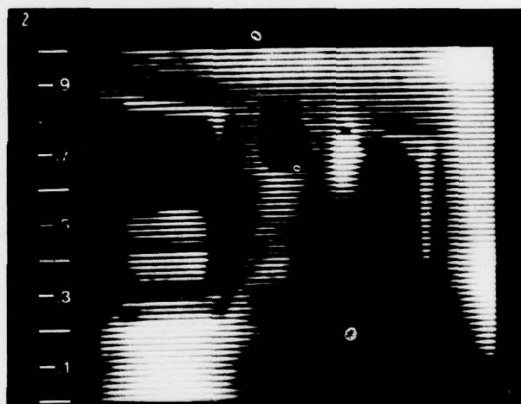
Figure 116. Window and door exfiltration leakage and solar effect.

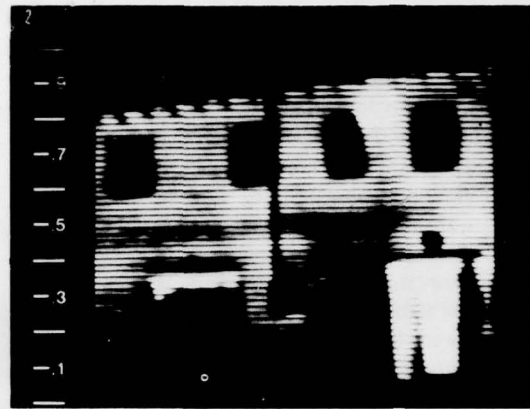
Figure 120. Excessive leakage from glass main entrance.

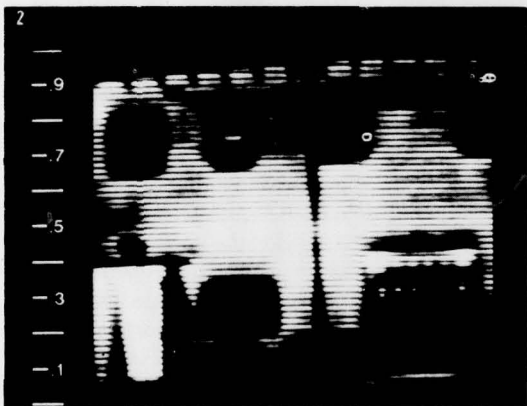
Figure 121. Leakage along top interface of garage door.

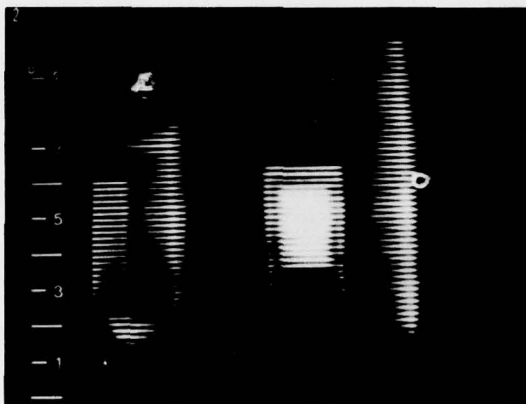
Figure 132. Leakage on north face.

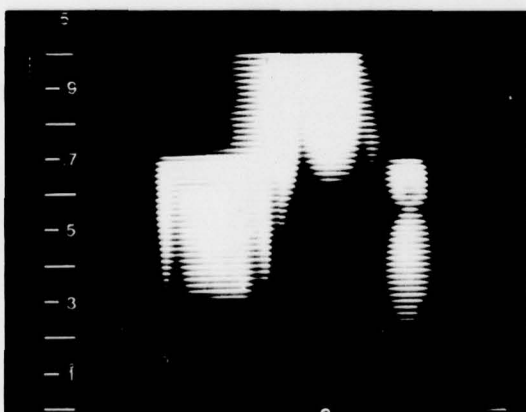
Figure 136. Plume of warm air from vent to right of chimney.

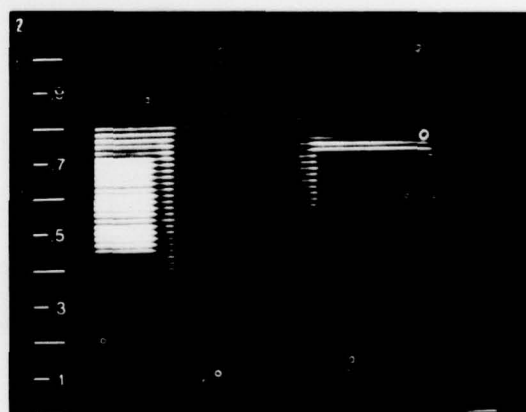
Figure 137. Paint storage locker doors losing heat.
